Navajo Abandoned Uranium Mine

Site Screen Report

Mine Name: Sam Charley No. 1
Mine ID: 86

August 2011

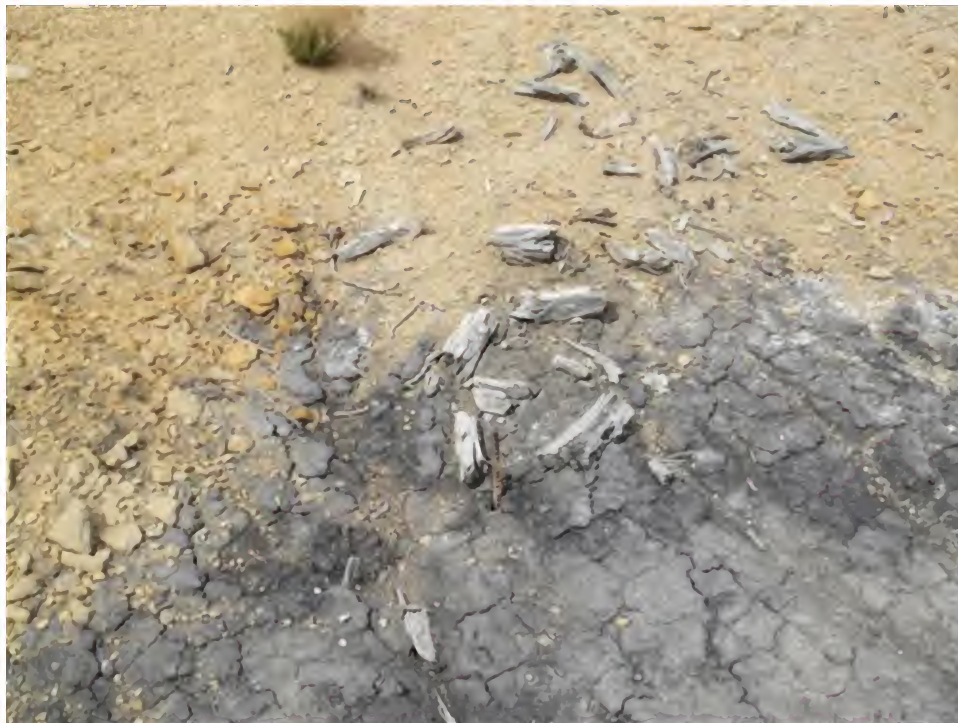
Photo 3: Mine Site #86; Rebar

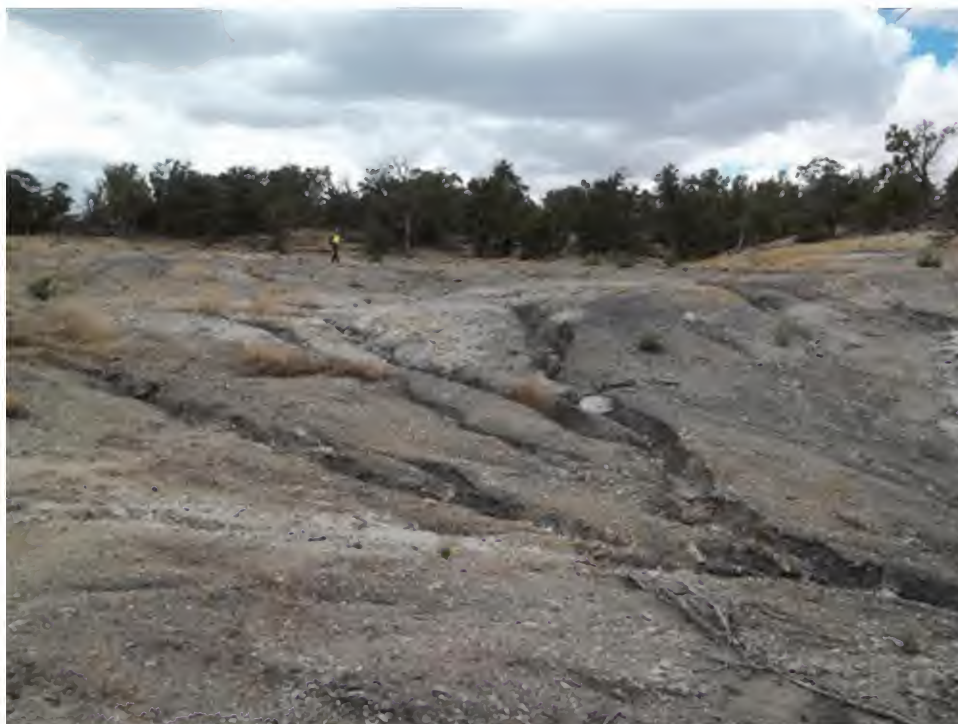
Gray soil cap over mine surface area, eroded to bedrock in southern portion of site

Photo 4: Mine Site #86; Erosion trenches
